Authenticity and the Perceptions of Significance

Examining Rust-en-Vrede in Durbanville, South Africa

A Mini-Dissertation (60-credit research project, course: APG5071S)
submitted in partial fulfilment for the degree of
M. Phil. in Conservation of the Built Environment

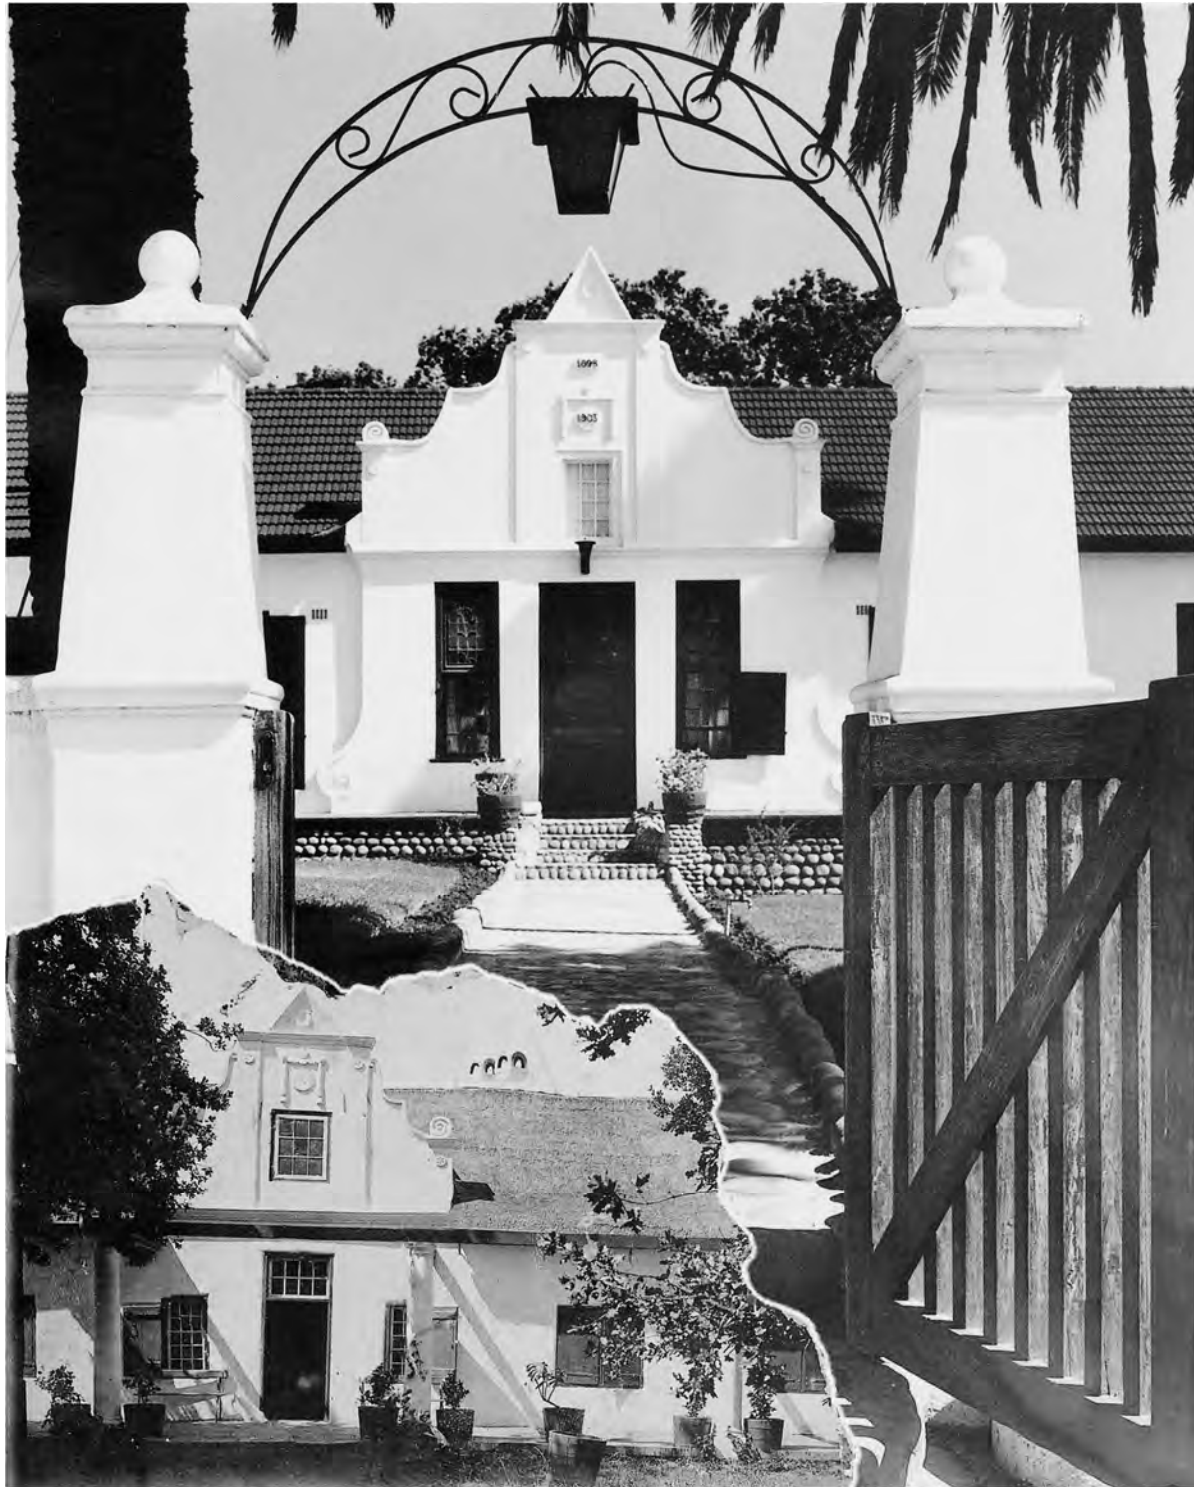
Figure 28: Pretorius noted that the new elaborate centre gable of Diemersdal was modelled on Lekkerwijn's gable. (The inset (bottom left) is of the Lekkerwijn homestead.) The simple gable was replaced by the owner, Matthys (Tienie) Louw, shortly after purchasing the property in 1903. (In 1962 his son, Matthys, replaced the corrugated sheeting roof with tiles, and the gable was strengthened and the windows enlarged.) (Source: Pretorius, 1997, p. 23.)

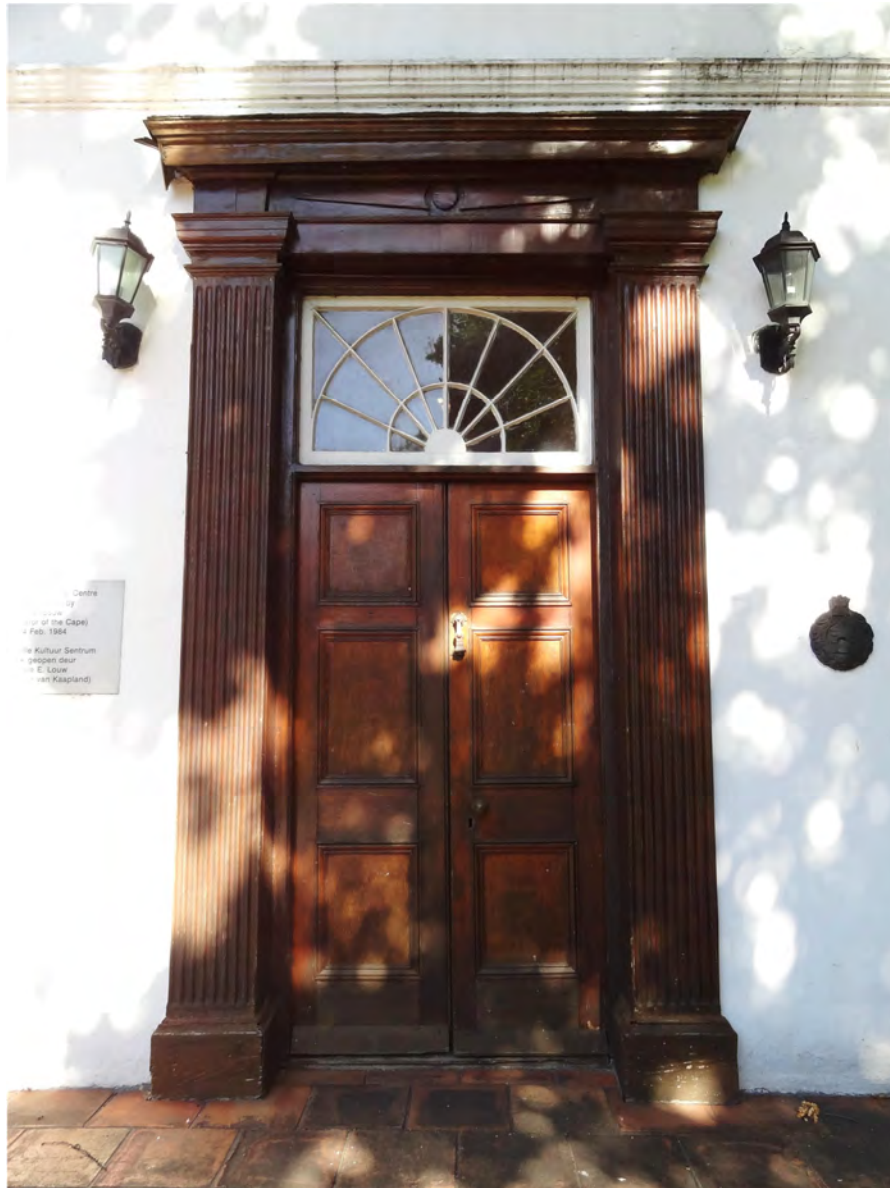
*Figure 29: Photograph of the Georgian front door that was introduced into the front façade, as the front door to The Oaks.
(Source: J. de Waal, 30 January 2014.)*

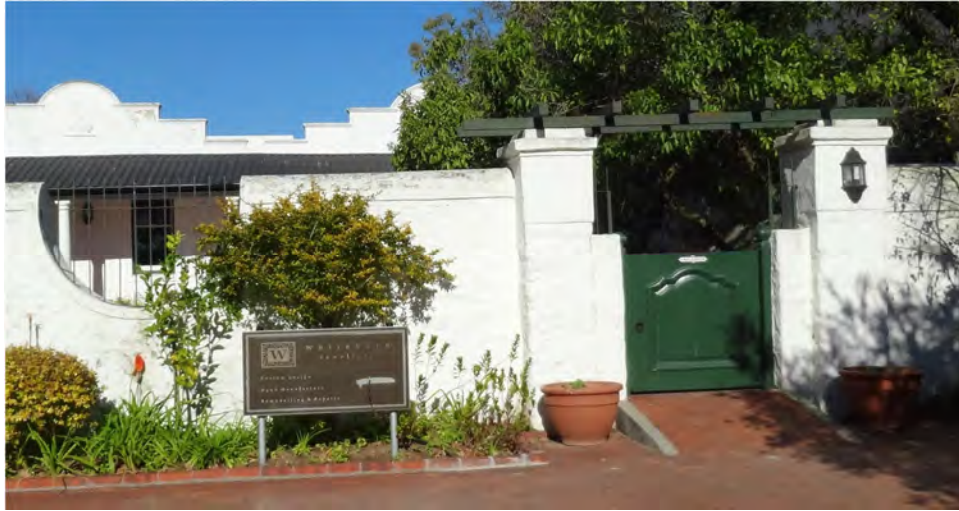
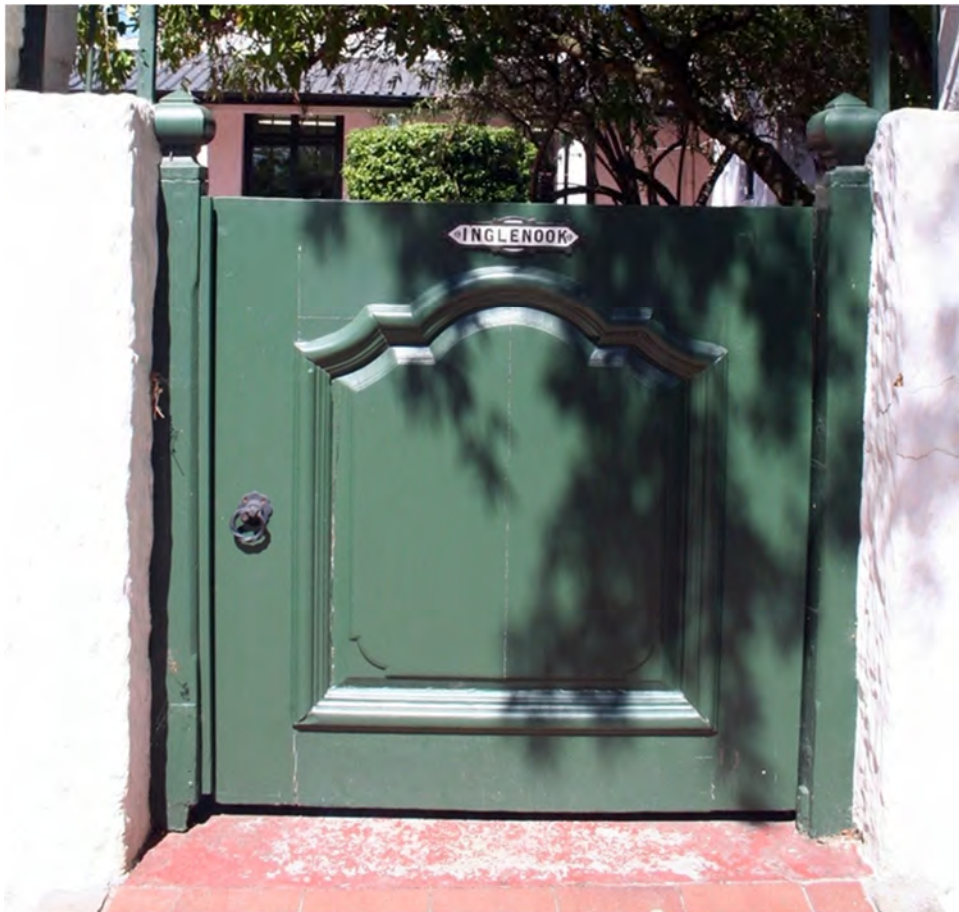
Figure 30: The gate of Inglenook is the top section of an old “bo-en-onder deur”. This could possibly have been part of the original front door before it was replaced with the Georgian front door. (Source: J. de Waal, 29 June 2013 and Hamlin Jansen van Vuuren, March 2014.)

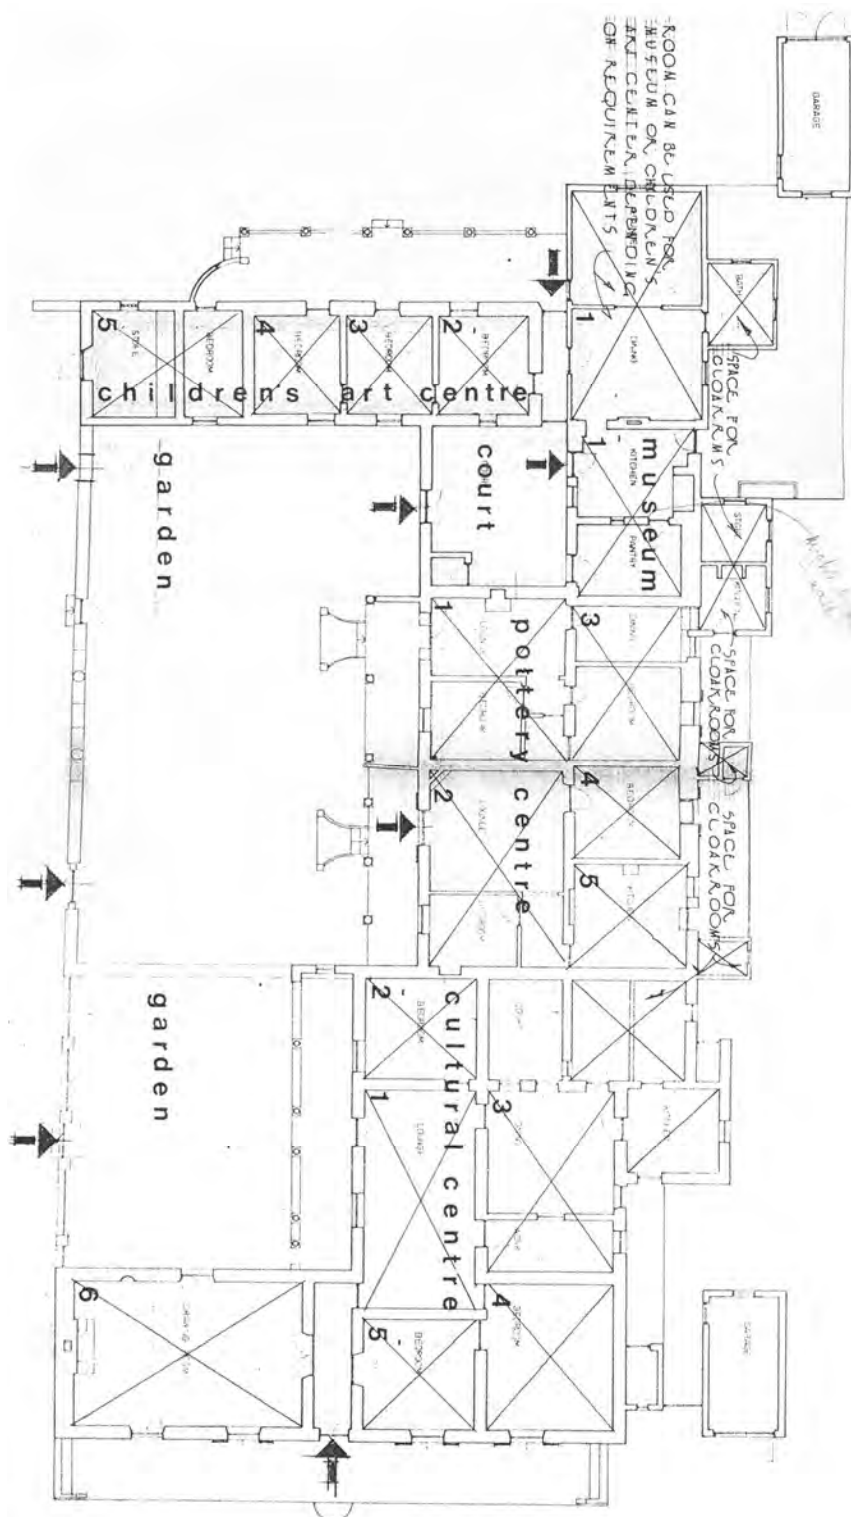
Figure 31: Drawing reflecting the proposed new uses for the building complex Rust-en-Vrede in the architects' report of 1981. Many internal walls were assigned to be demolished to accommodate the new functions of the cultural centre. The full extents of all the internal walls, which were to be demolished, were not clearly indicated. (Source: Conidaris & Greshoff Architects. 1981, 12. Drawings.) Also see Annexure 9 which records the current layout of the building and the use of each room.

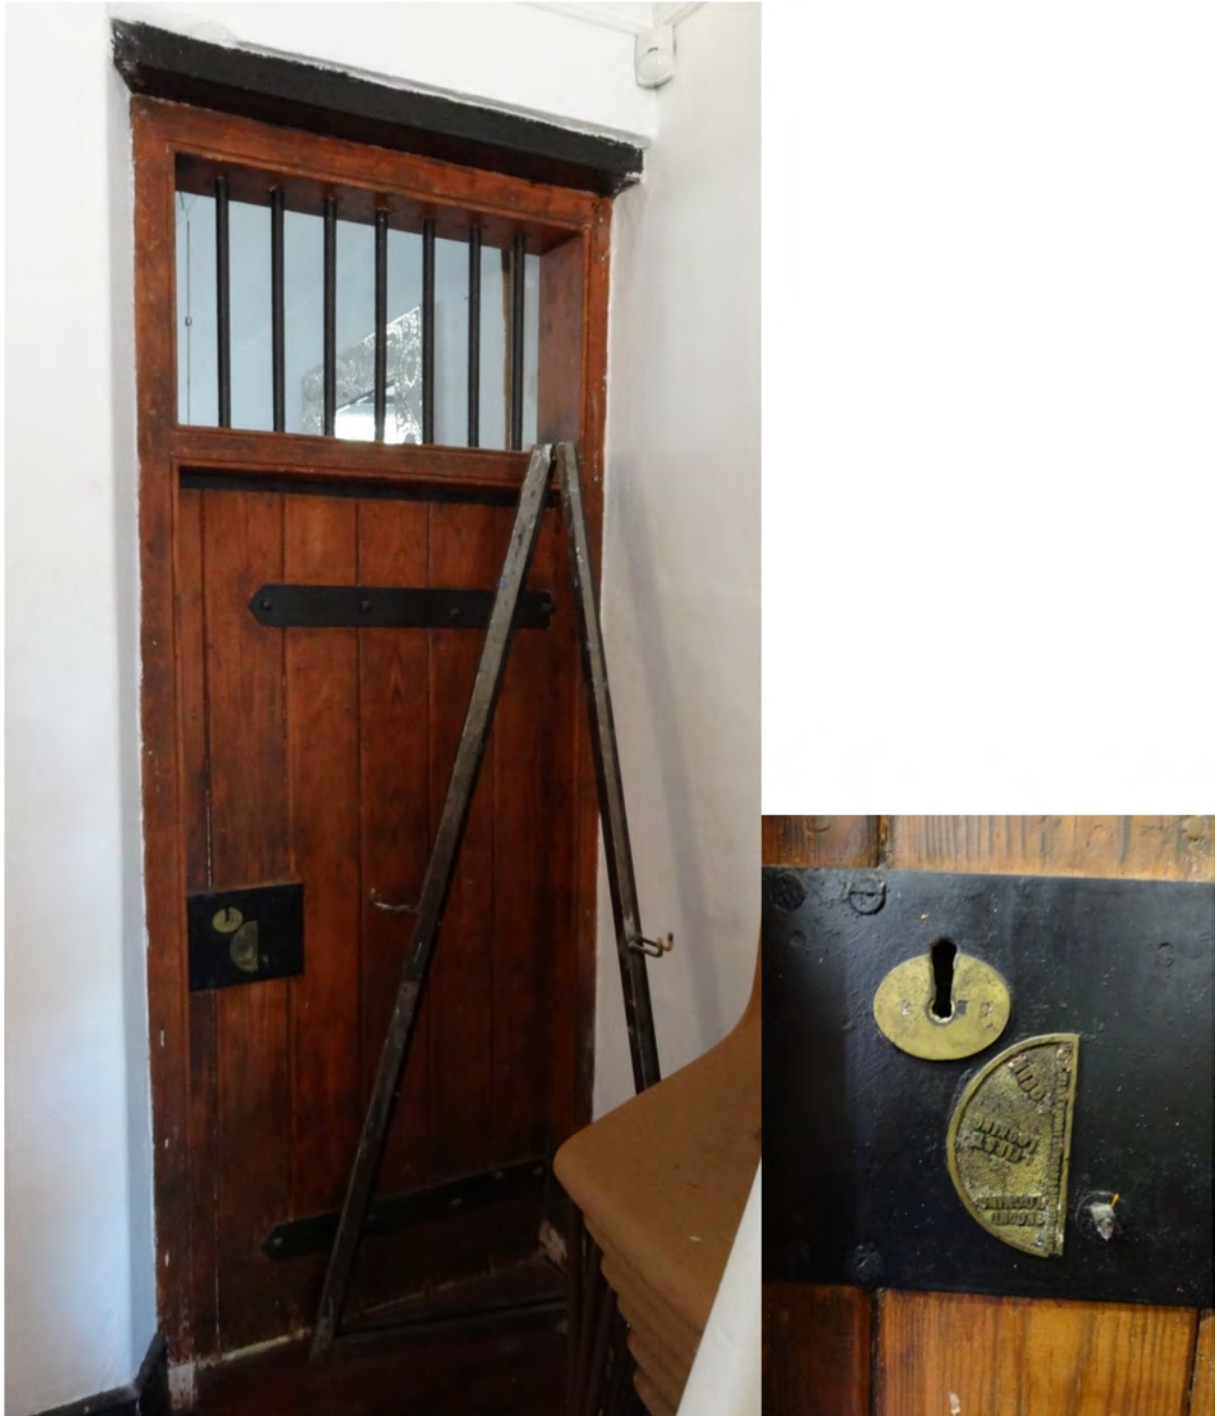
Figure 32: Original cell door remains part of the building fabric, dating back to c1850s, with upside-down lock indicating three settings: second locking, first locking and open. (Source: J. de Waal, 13 August 2013.)

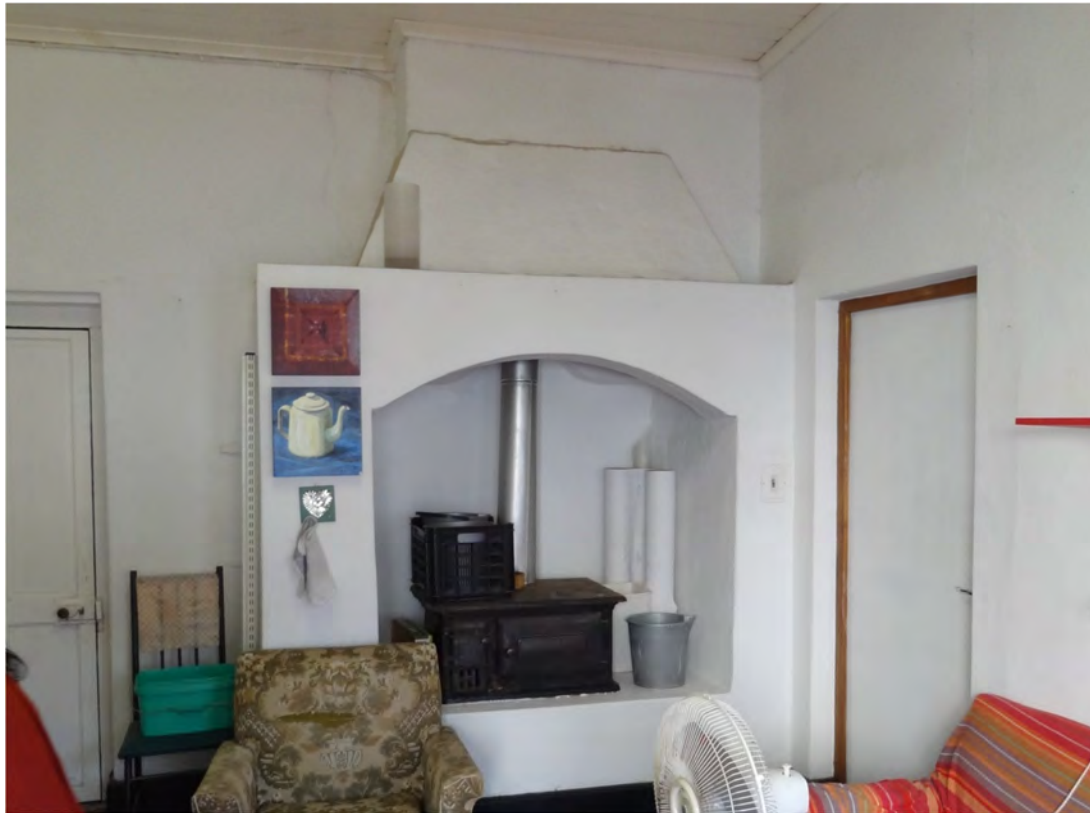
Figure 33: One of the two remaining kitchen hearths. The hearth is located within the previous extents of the home My Vreugde and the cast-iron stove is still in place. (Source: J. de Waal, 13 August 2013.)

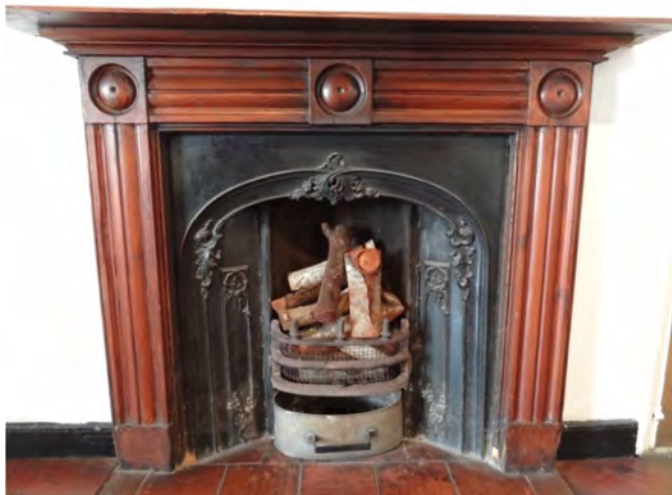
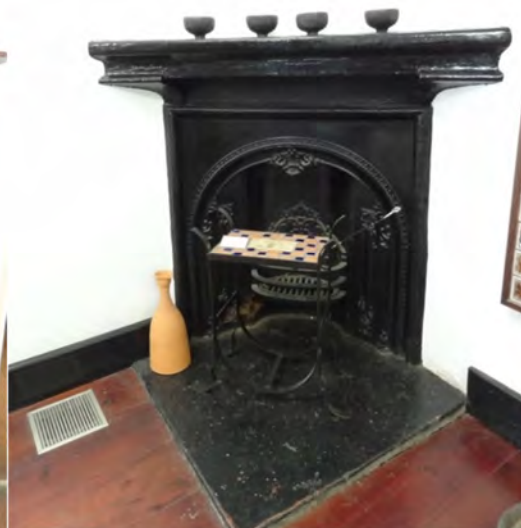
Figure 34: Two of the cast-iron fireplaces that were probably installed during the Meneely's ownership. The image of the fireplace with the wooden surround was taken in the lounge of The Oaks and the corner fireplace in Inglenook. (Source: J. de Waal, 12 December 2013.)

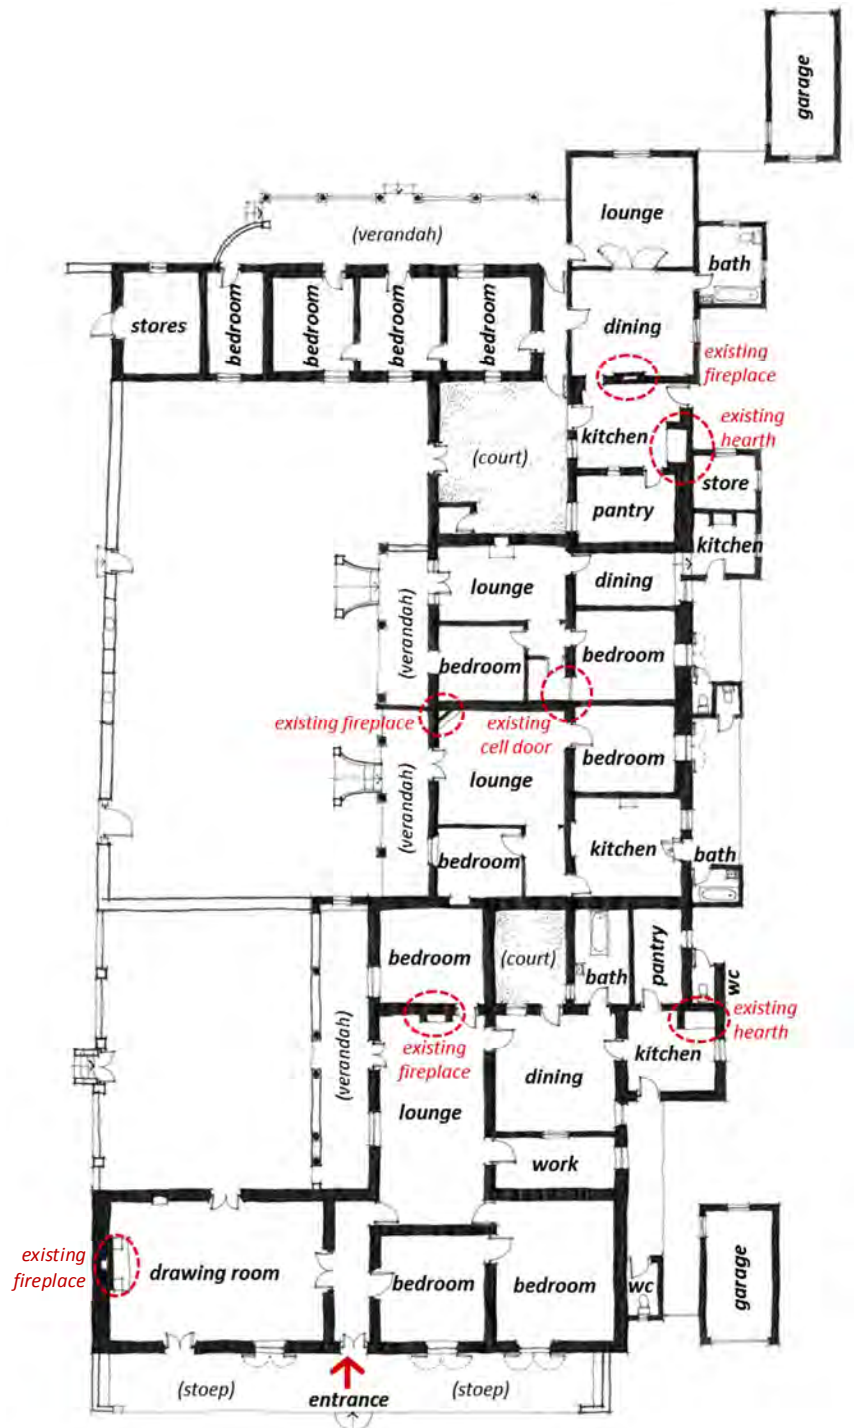
Annexure 8

A sketch illustrating the layout of the Meneely House (layout as documented in 1979) indicating the locations of various building elements that were retained. The drawing has been created by using the layout of Figure 23. Annexures 9 and 10 illustrate the internal changes that were made when the four houses were converted into a cultural centre and larger spaces and less bathrooms and kitchens were required. (Drawing by J. de Waal.)

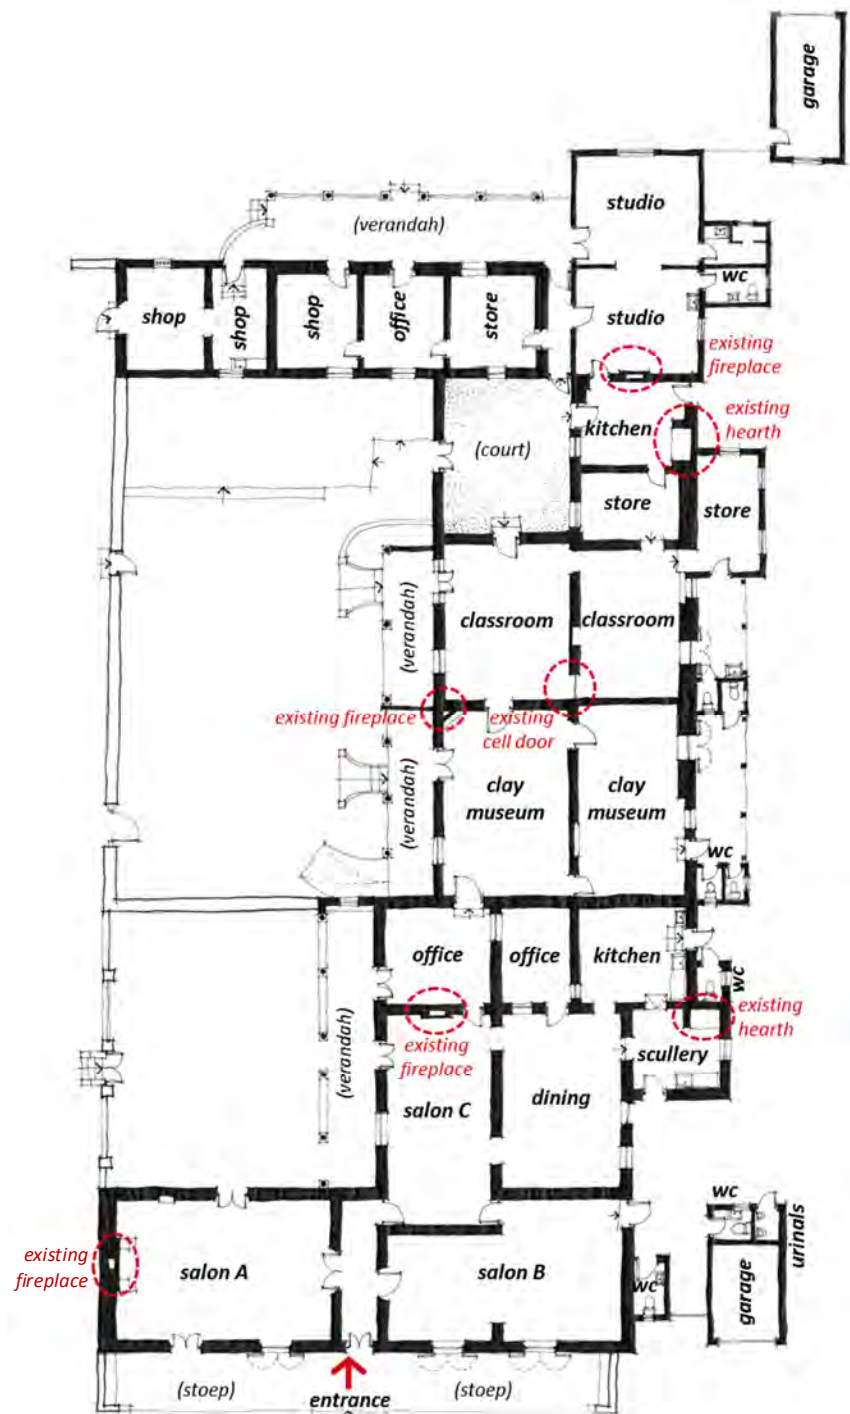
Annexure 9

A sketch illustrating the current layout of the building complex, Rust-en-Vrede (layout as documented in 2014). The drawing has been created by using the layout of Figure 23, updated with information gathered on site. Annexures 9 and 10 illustrate the internal changes that were made when the four houses were converted into a cultural centre and larger spaces and less bathrooms and kitchens were required. (Drawing by J. de Waal.)
